**GEO-ENVIRONMENTAL ASSESSMENT
PROPOSED RESIDENTIAL DEVELOPMENT
LAND OFF WORKSOP ROAD, MASTIN MOOR
CHATSWORTH SETTLEMENT TRUSTEES
GEA-19412-17-201
SEPTEMBER 2020**

GEO-ENVIRONMENTAL ASSESSMENT
PROPOSED RESIDENTIAL DEVELOPMENT
LAND OFF WORKSOP ROAD, MASTIN MOOR
CHATSWORTH SETTLEMENT TRUSTEES
GEA-19412-17-201
SEPTEMBER 2020

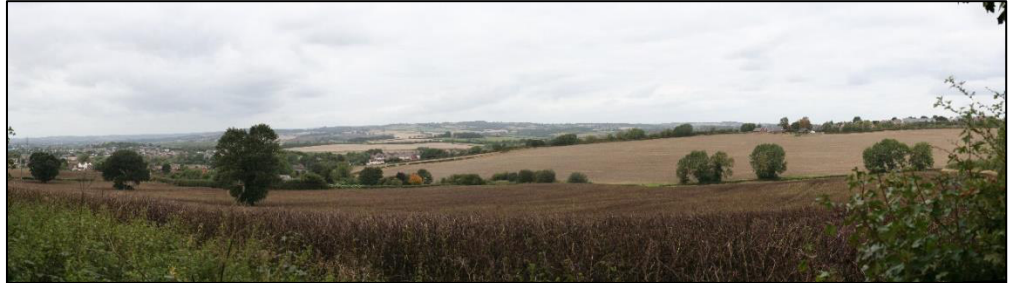
Photo 1: View over site from South-Eastern corner (adjacent Woodthorpe Road) looking towards Woodthorpe

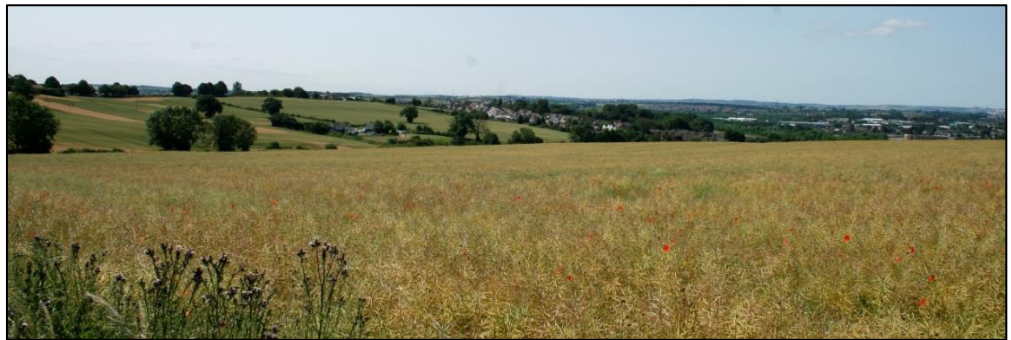
Photo 2: View over site from Bolsover Road (close to Community Garden) looking towards Woodthorpe

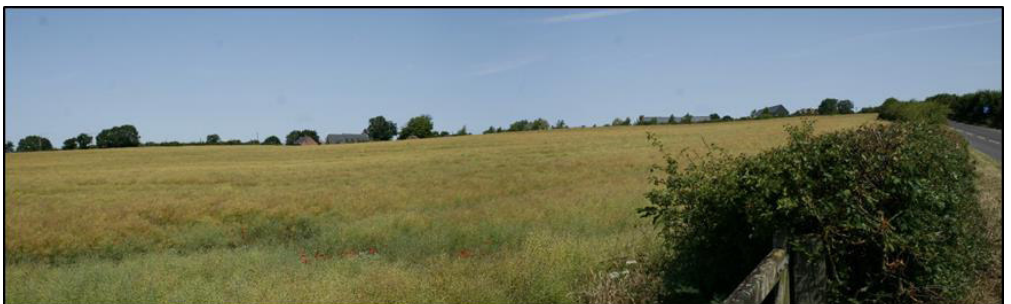
Photo 3: View over site from Northern boundary (rear of former Community Building adjacent to Worksop Road) looking towards Woodthorpe Road and Woodthorpe

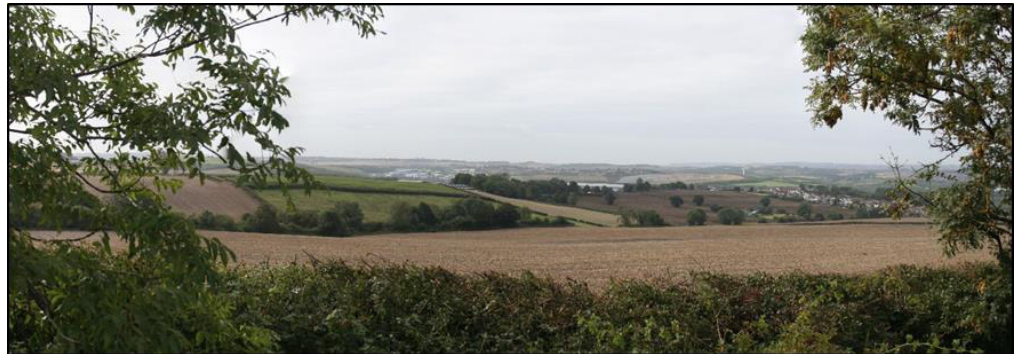
Photo 4: View over site from near North Eastern boundary adjacent to Worksop Road looking towards Bolsover Road and Woodthorpe

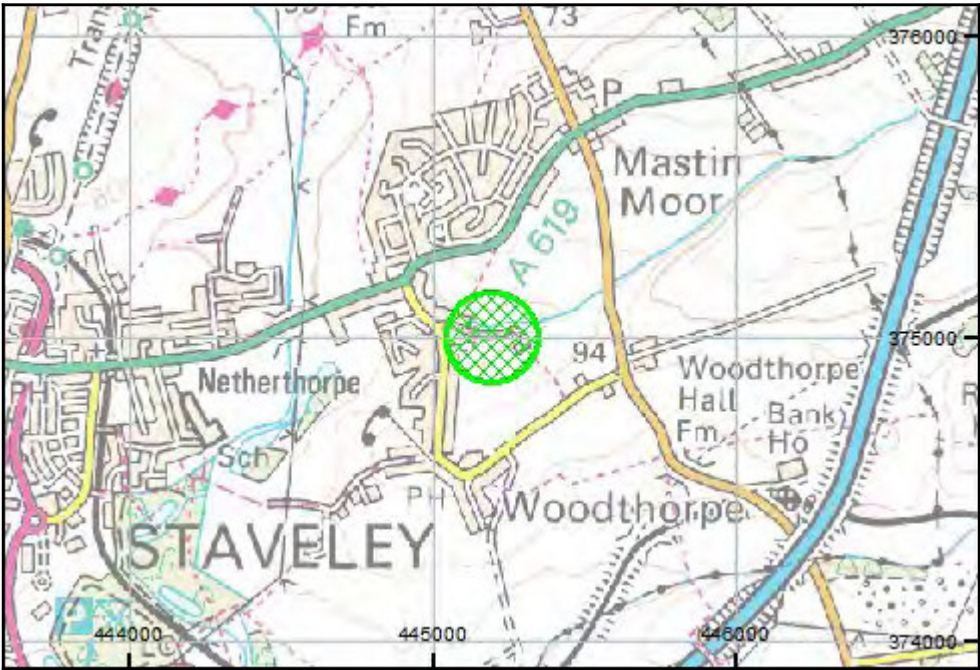
Location map

This plan shows the approximate location of the disused mine entry / entries referred to in the attached mining report. For reasons of clarity, mine entry symbols may not be drawn to the same scale as the plan.

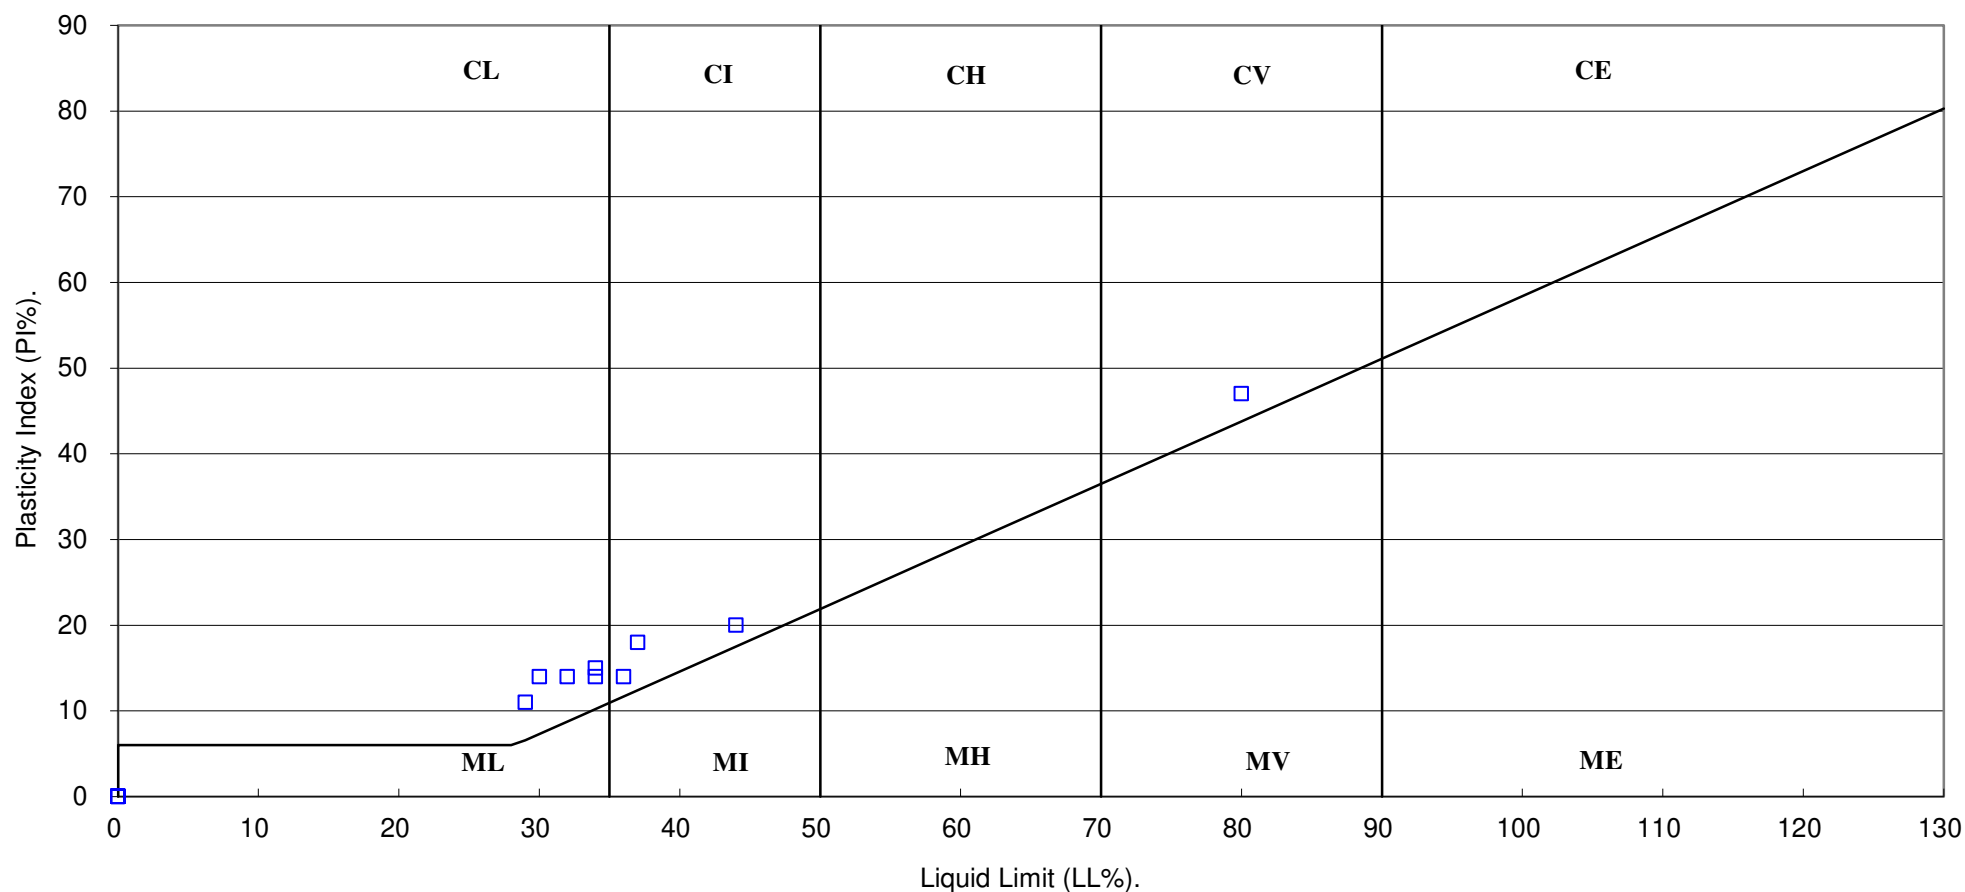
PLASTICITY CHART FOR CASAGRANDE CLASSIFICATION.

(B.S.5930 : 1999)

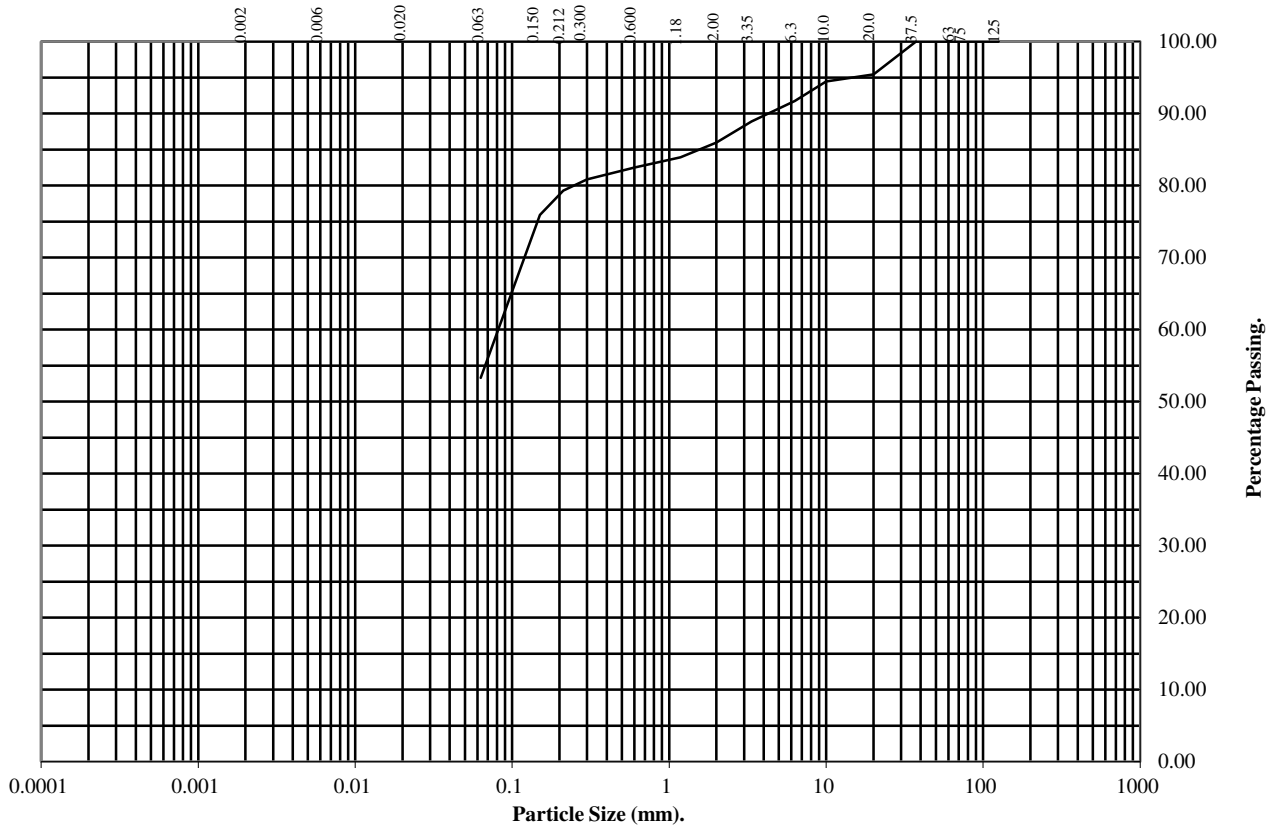
BS Test Sieve	Percentage Passing
125	100
75	100
63	100
37.5	100
20	95
10	94
6.3	92
3.35	89
2	86
1.18	84
0.6	83
0.3	81
0.212	79
0.15	76
0.063	53

Soil Fraction	Total Percentage
Cobbles	0
Gravel	14
Sand	33
Silt / Clay	53

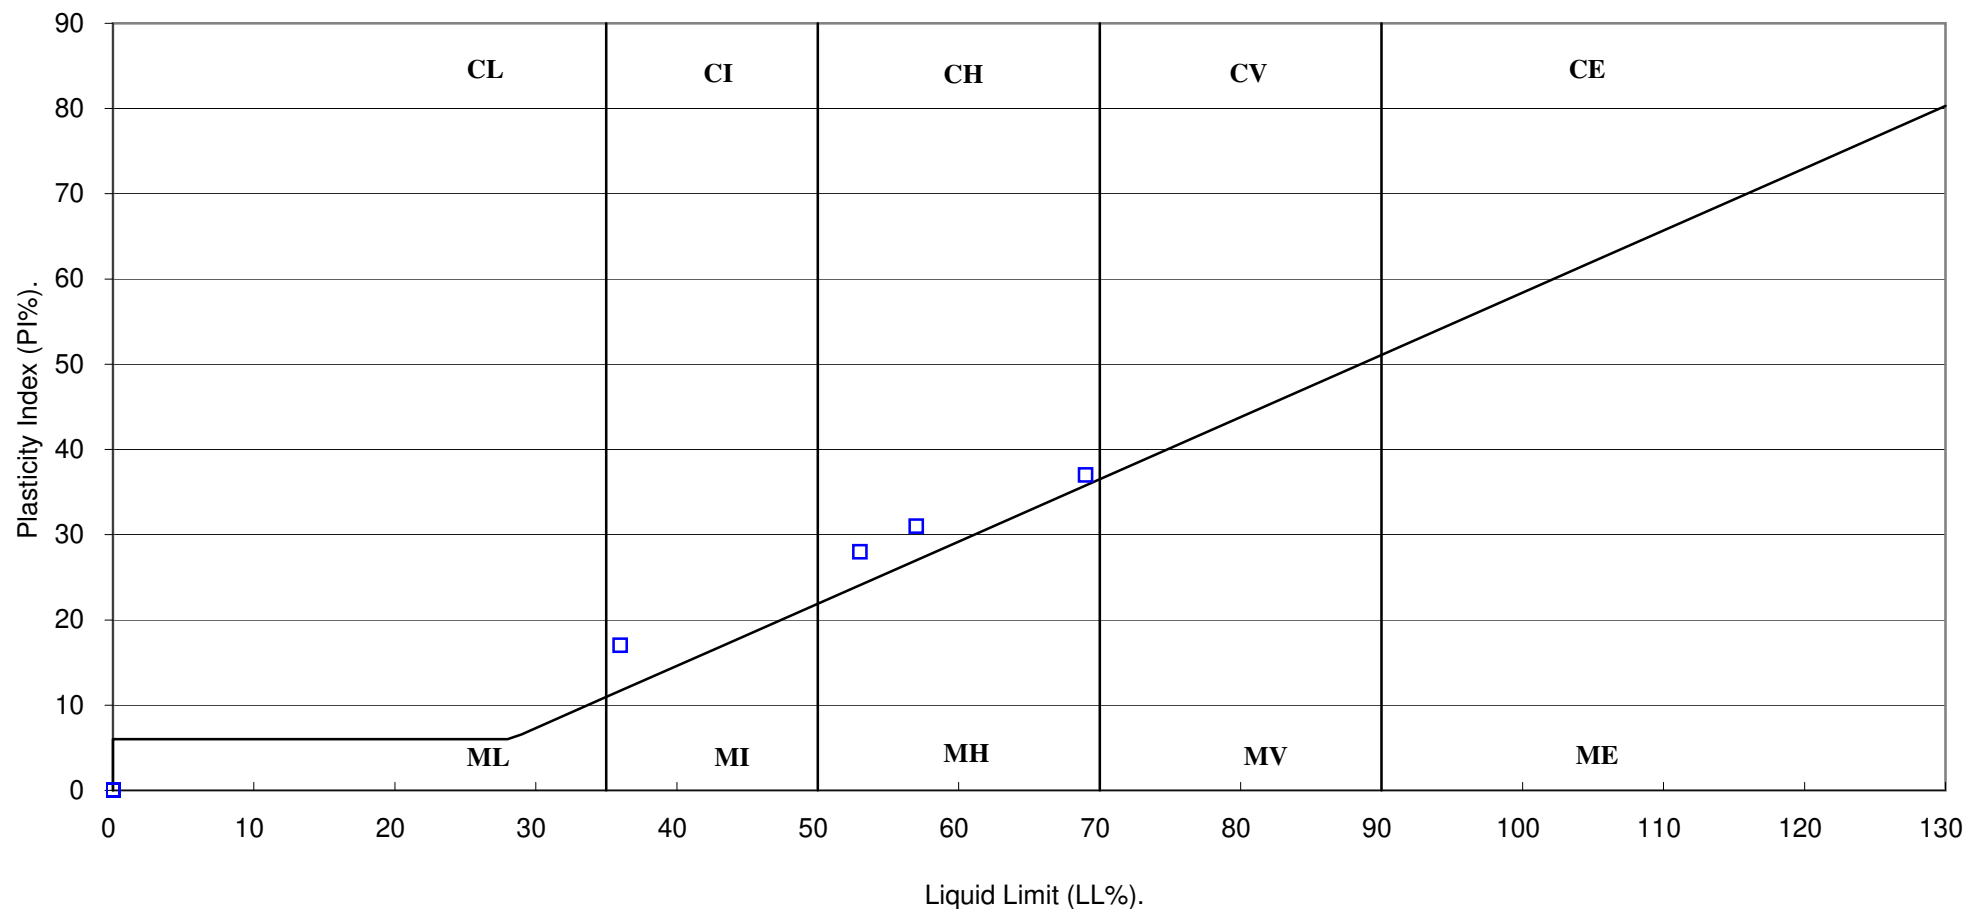
PLASTICITY CHART FOR CASAGRANDE CLASSIFICATION.

(B.S.5930 : 1999)
